Prevention of Oil Leakage in Planetary Pin Groove of Hub Case Assembly

In this present investigation Oil seepage is a major problem occurred in the area of hub case of a hub reduction axle, which is designed at Meritor Mysuru. This paper contains a number of methods used to overcome from the seepage issue, their efficiency and other programs we need to consider to beat the problem and continue problem less manufacturing of axles.

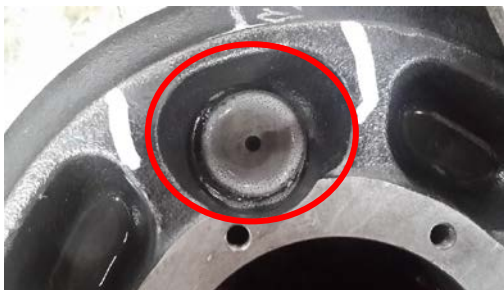
Fig. Leakage area.

Above figure shows exactly where the leakage is happening in the hub case. After the leak test is done at the manufacturing plant, we came to know that the leakage was happening exactly at the groove. Parts involved here are Planetary pin, Groove, O-ring and some

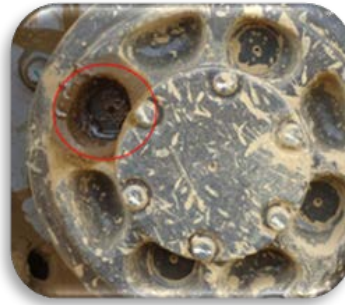
Oil Seepage Through Wheel- end Planetary Pins
