Prevention of Oil Leakage in Planetary Pin Groove of Hub Case Assembly

By

Ajay S P¹, Prof. Murali Kumar L²

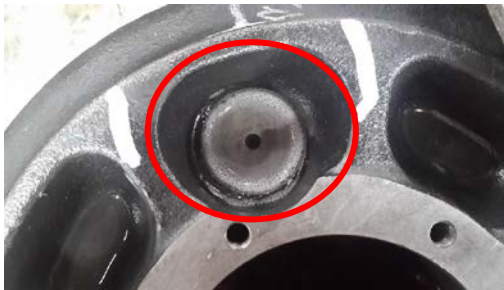
Fig. Leakage area.

Above figure shows exactly where the leakage is happening in the hub case. After the leak test is done at the manufacturing plant, we came to know that the leakage was happening exactly at the groove. Parts involved here are Planetary pin, Groove, O-ring and some

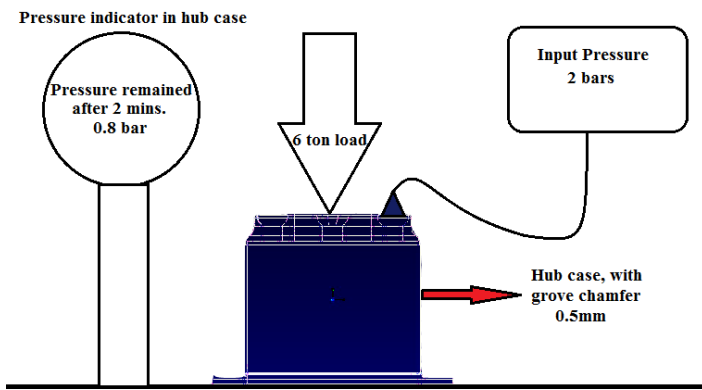
Trial No. 1:

Leak test trial no. 1.

Providing chamfer for the groove by trial and error method.

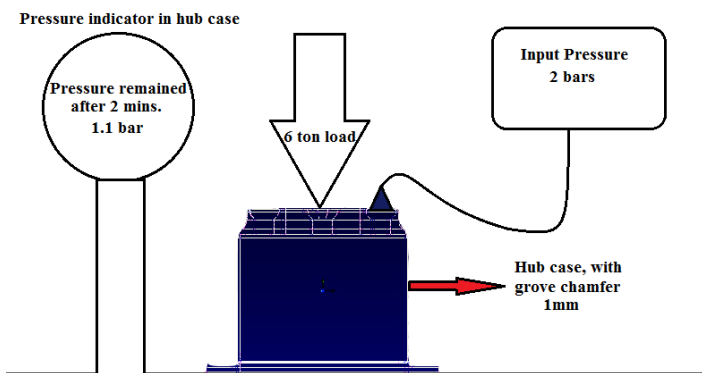
Trial No. 2:

Leak test trial no. 2.

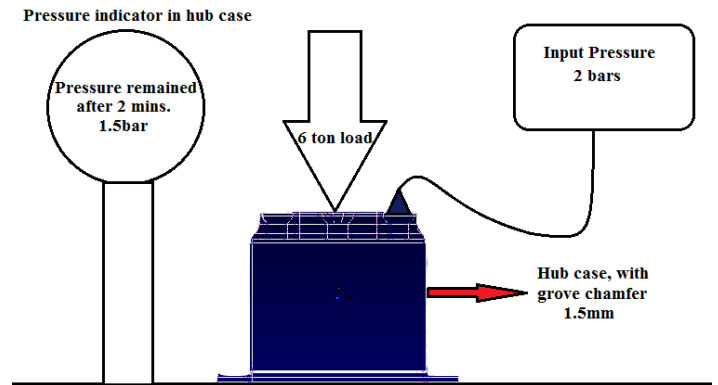
Trial No. 3:

Leak test trial no. 3.

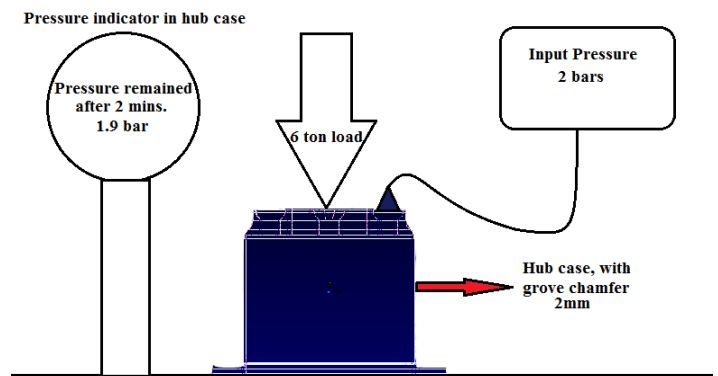
Trial No. 4:

Leak test trial no. 4.

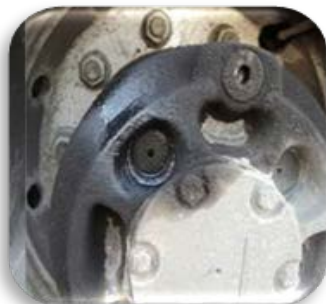
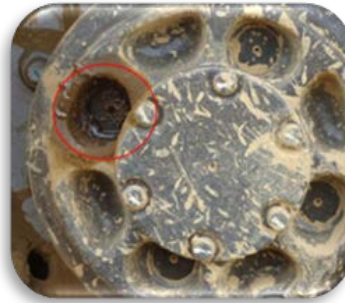
Oil Seepage Through Wheel- end Planetary Pins

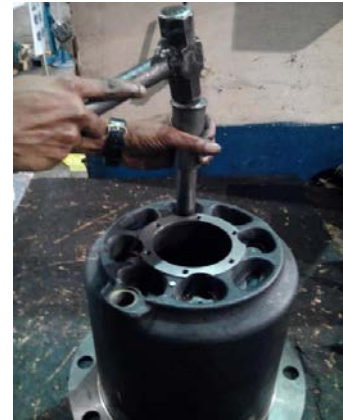
We did air leak test, checked for chamfer cutting, surface hardness and finally plotted the fish bone diagram. Later after all investigation and tests, the planetary pin was assembling manually which was effecting to chip off of the pin edges and also groove edges. We changed the chamfer dimension from 0.2 to 0.5 which reduced the sharp edges. Sharp edges leads to stress concentration factor and breaks up easily. Air leak test changed from assembly line to separate leak equipment so the leak test is increased from 1.5 to 2 bar pressure. Core shift were studied using the cp & cpk which is process capability and process capability index. This was studied and corrected the cp value to greater than 1.3, this is a standard value and greater than 1.3 is a good process according to process capability study. Surface hardness was ok. Then O-ring used was not having any kind of defect. The ultimate objective is to increase productivity through system simplification, organizational potential and incremental improvements by using modern technique like Kaizen. Hence the seepage is eliminated easily.

Manual Assembly

- a) Cp & Cpk study should be very compulsory for every process of manufacturing, which for us to reduce the core shift.
- b) Should not lead to stress concentration factor or sharp edges.
- c) The manual assembly should be eliminated for précised parts to maintain tolerance and reduce chipping off of the planetary pin edges.
- d) From leak test we concluded that the pressure should be in the range of 1.5pa to 2pa.

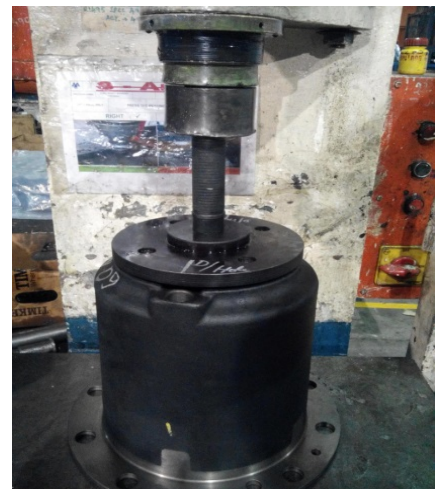
Assembly using machine

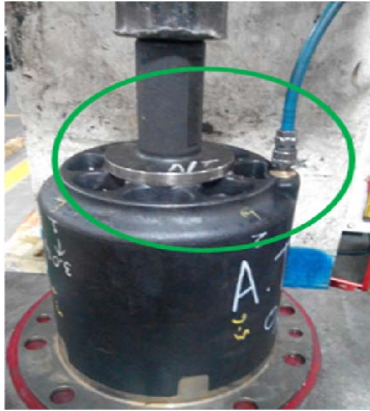
Air leak test 1.5 – 2 bar pressure
