# Rain Erosion and Degradation of Infrastructure in The District of Detohou in The Municipality of Abomey in Benin

Populations outside the innumerable problems they experience in the exercise of their activities are confronted in recent years with the effects of climate extremes. The present study aims to study the impact of rain erosion on infrastructure in the district of Detohou..

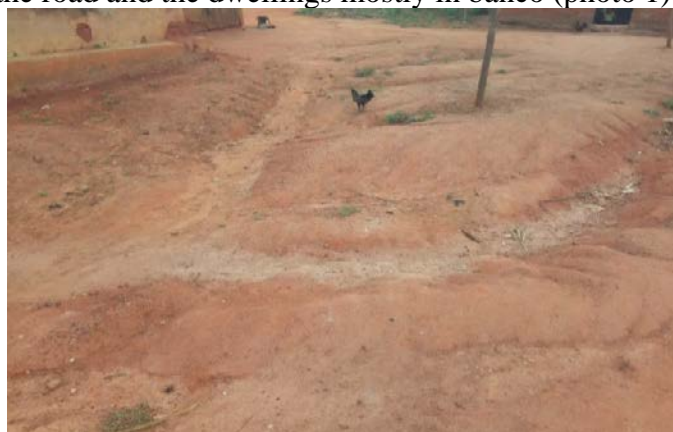
Photo 1: State of the Road in Détohou

In sum, the meticulous examination of the district of Détohou shows that urbanization is still in its infancy. This is evidenced by the almost total absence of infrastructure characteristic of the district, the state of the road and the dwellings mostly in banco (photo 1)

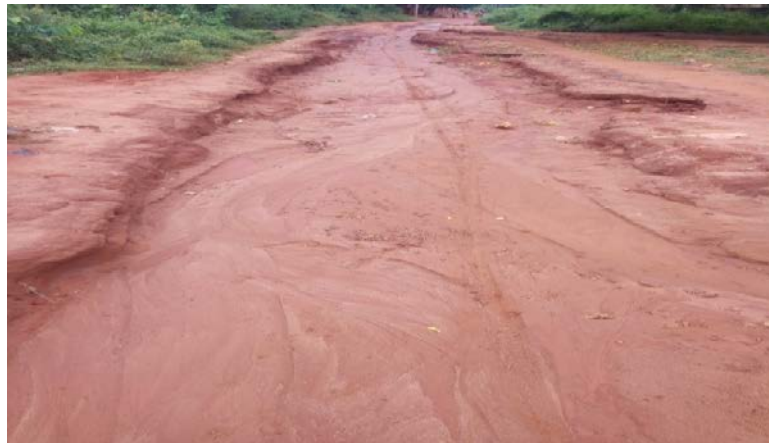
Photo 2: Degradation of the tracks

The extent of the erosion of road infrastructure, the roads in the district of Détohou are completely degraded. The degradation of the roads is one of the factors that accounts for the impact of rain erosion on the ground in the Détohou district (more than 80% of the roads are degraded). This degradation appears in several forms given the magnitude of the runoff. These are incisions and channels.

The analysis of this photo 2 shows that it is especially the streets that are most exposed to the phenomena of erosion in the borough of Détohou.

This degradation appears in various forms given the importance of runoff. These are incisions, channels, and gullies.

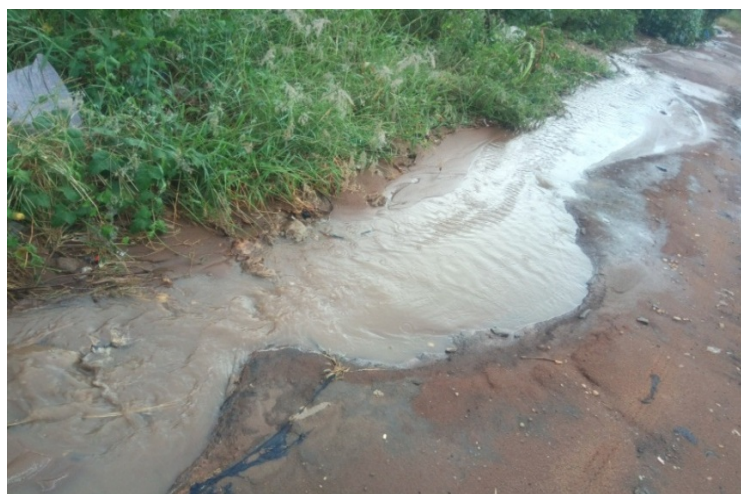
Photo 4: Funny to Detohou

They result from the progressive widening of the incisions left by the traces of the runoff on the bare ground (photo 4). They draw more or less sinuous paths with very irregular transverse profiles. These transverse profiles have a depth that varies between 10 and 20 cm..

The arrondissement of Détohou is filled with several channels left by runoff, like the one shown in Photo 4.

This ravine is gradually set up by the flowing water. It divides the street in two and makes the houses that are nearby difficult to access.

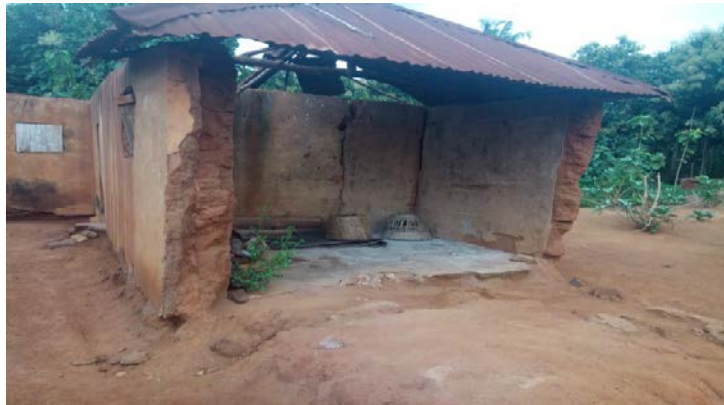
Photo 5: Housing in a fall position in the district of Détohou

Loosening occurs after the layer of earth that protects the foundation of the houses is completely torn off by undermining or ravining. In this case the houses, especially in banco are either partially or totally destroyed (photo 5).

This photo shows the condition of some buildings that have been removed. The building in Photo 5 has half collapsed due to the action of erosion. Through these photos, we realize the difficulties that the populations face in the face of rain erosion in the district of Détohou.

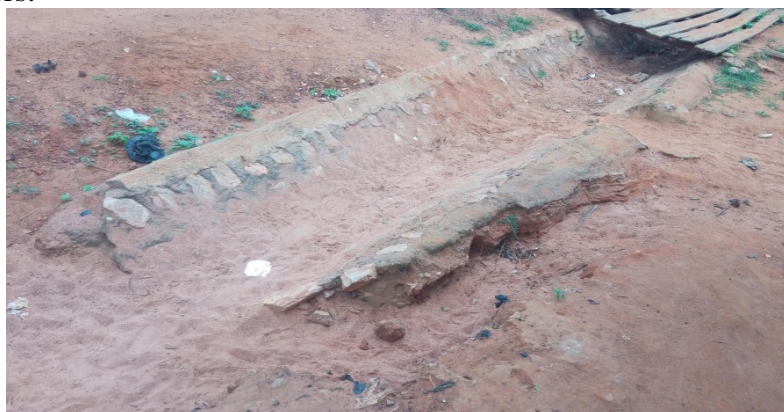
Photo 6: Damaged water pipe in Detohou

Direct observations on the ground have also helped to assess the vulnerability of public service buildings to rain erosion (Photo 6). The infrastructures affected by the effects of erosion are largely the gutters.

Photo 6 shows a primary gutter whose base has been undermined by erosion and which is almost in the ravine. The state of advanced degradation of these infrastructures is explained by their installations in sectors with steep slopes and especially on slopes that serve as flow paths for runoff water.

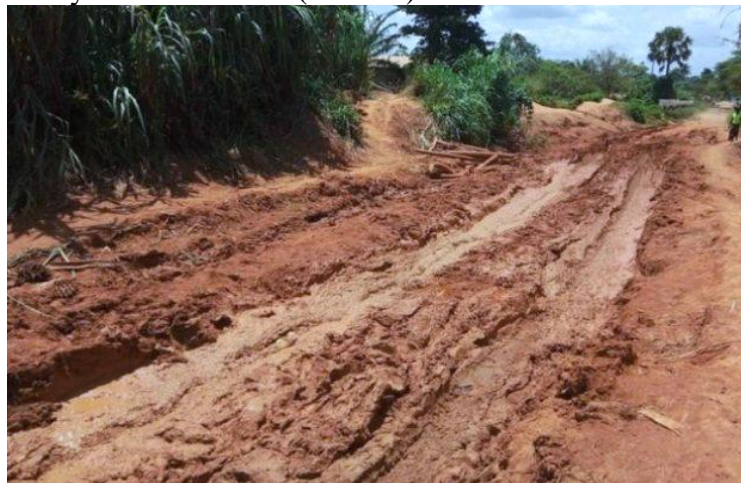
Photo 7: Impassable way to Detohou

The degradation of the infrastructures, the presence of claws, gullies or channels on the approaches of the tracks disrupt the circulation of goods and goods through the borough of Détohou. Even pedestrians experience traffic difficulties on certain lanes for fear of falling into channels or gullies. The consequence of all these difficulties is that economic activities are slowed down or sometimes blocked because of the impassability of the roads, thus creating a decrease in their already modest income (Photo 7).

Photo 7 shows a degraded road which the population of the Détohou district is having great difficulty crossing.

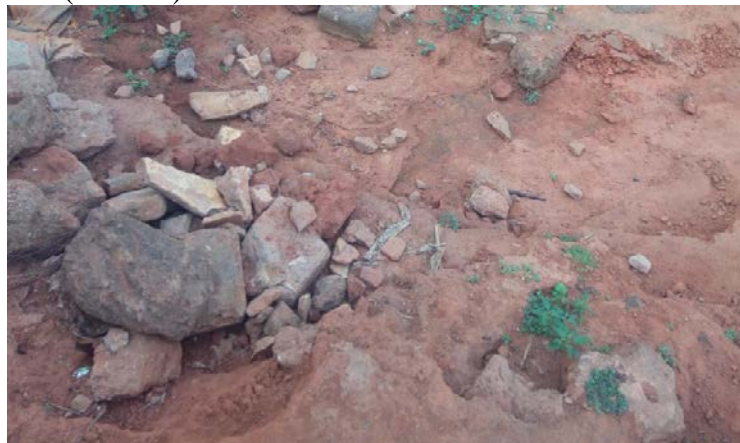
Photo 8: Deposit of pebbles for the endogenous protection of houses in Detohou  
Shooting: Ouassa, August 2017

Photo 8 shows the embankments by the bricks at the front of a house to stop the phenomenon of erosion. This practice is less effective in limiting the damage caused by rain erosion which erodes the walls of houses. The population sometimes, for lack of modern means, uses stone blocks, terraces to girdle the foundation of their habitat.

This method aims to lay blocks of large stones at the level of the over-digging of the ground to slow down the passage of water and retain all the other elements drained by the water during its passage. It plays the same role as the bags filled with sand or pebbles deposited on the rainwater route. These stone blocks are also deposited along the foundations to prevent the collapse of the houses (Photo 8).

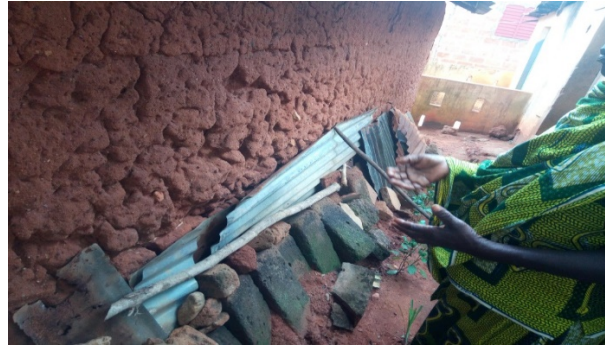
Photo 9: Device for protecting the foundations of houses in Detohou

Photo 9 shows a house whose foundation is supported by stones and bricks interlocked one after the other.

To protect the foundations, the populations are developing techniques such as: filling or earthmoving and crossing structures. Photo 9 shows a device for protecting the foundations of houses in the district of Détohou.

This method is used to protect banco houses with a loose foundation.

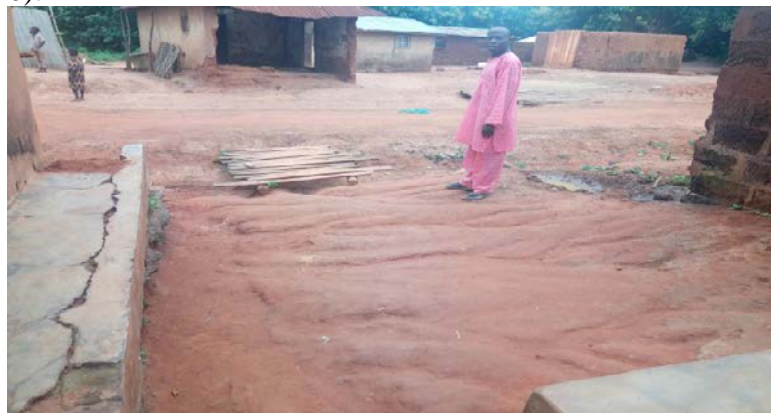
Photo 10: Wood dam technique in Detohou

The analysis of Photo 10 shows the damming technique made using wood.

This practice consists of simply planting stakes or stakes crossed with woods. It allows the rainwater to run off, but the device retains the sand and debris drained by this water. The limitations of this device is, that it is easily destroyed by the combined action of water and termites (photo 10).

This technique is used to make circulation easier.

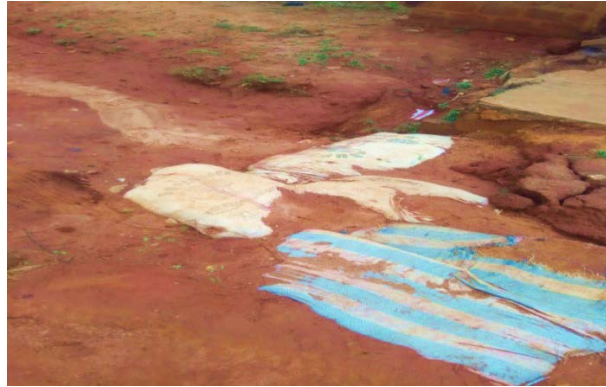
Photo 11: Sandbag dam in Detohou

This photo 11 shows bags filled with sand arranged to stabilize the particles torn off upstream and to channel the water. This practice is easier and less expensive.

The populations deposit bags filled with sand in the rainwater flow corridors perpendicular to the direction of flow. The duration of the resistance of these sandbags is low and varies between about 4 to 8 months. They are exposed to variable atmospheric conditions. It is about the sunshine and the rain (acid runoff water). Also, unconscious men especially children and animals (pigs, chickens, rooster, etc.) exert negative influences on the bags filled with sand. Under these conditions, they tear and the contents are drained by runoff water. This method consists in aligning bags previously filled with sand in the ravines (photo 11). This technique is easier and less expensive.
