## SURGICAL REPAIR OF CROP FISTULA IN A HEN

A case of traumatic crop fistula in a 4 month old hen and its successful surgical management has been reported.

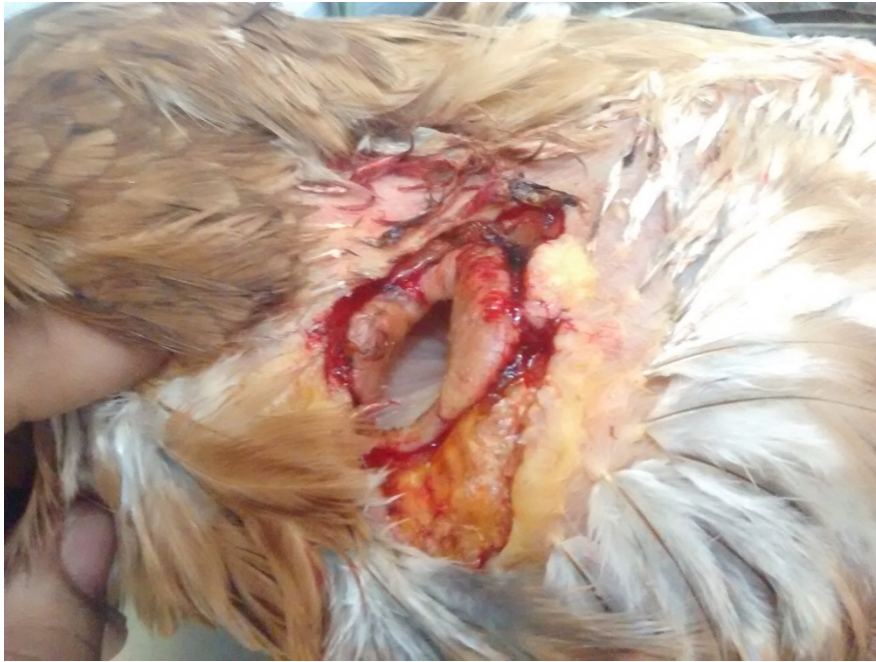
**Fig 1:** perforating wound on neck with ruptured crop in a hen

The feathers around the wound were plucked manually and ruptured crop was prepared for reconstruction. Crop was located and demarcated by passing a tube through the mouth. Under linear infiltration anaesthesia using 0.5 ml of 2% lignocaine, the ruptured crop edges were freshened and closed by using no. 2-0 chromic catgut with two layers of inverting pattern (Fig .2). Muscle and skin were closed routinely (Fig. 3). Post operatively, the hen was kept on cephalosporins 50 mg per kg and multivitamin drops bid PO for 7 days. The wound healed uneventfully.

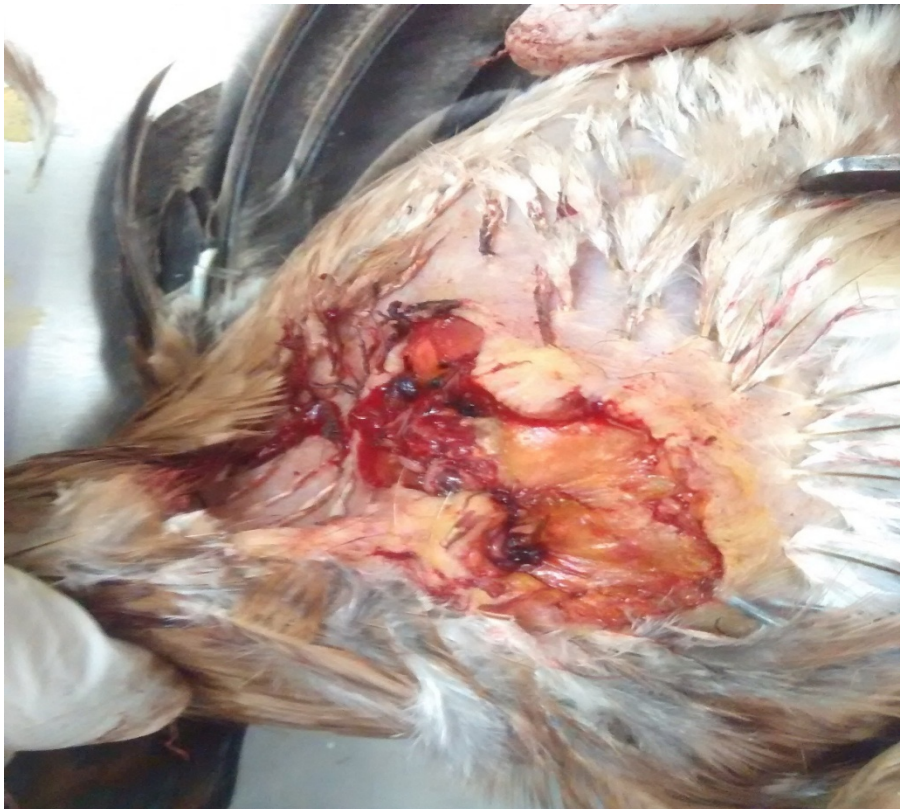
**Fig. 2:** Closure of Crop Fistula by inversion

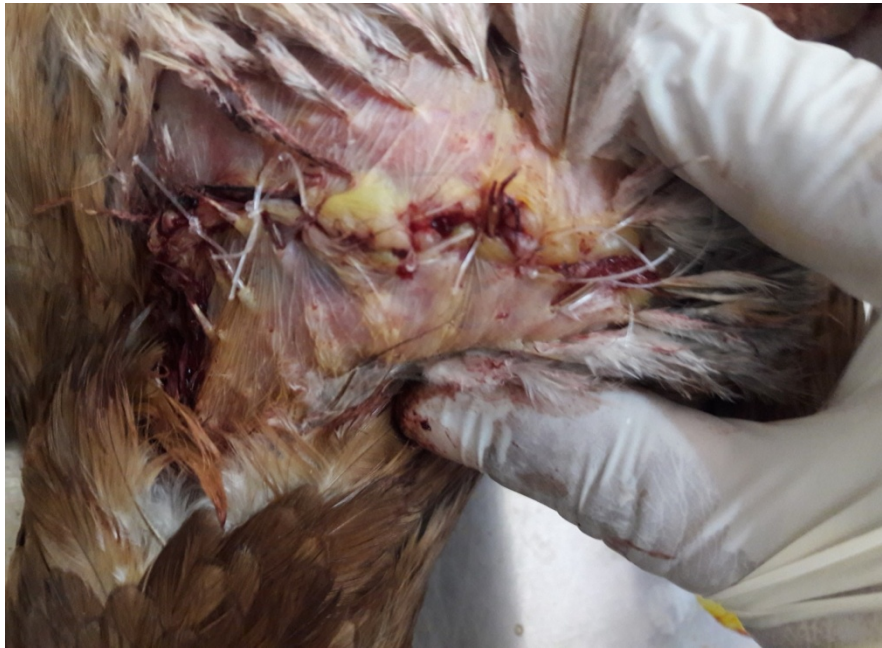
**Fig 3:** Skin closure with nylon
